## CAFO WPDES Compliance Report (6-17-14)

Inspection date: April 24, 2014

Inspection type: Compliance / Water Sampling

Operation Name: Ranovael Dairy LLC

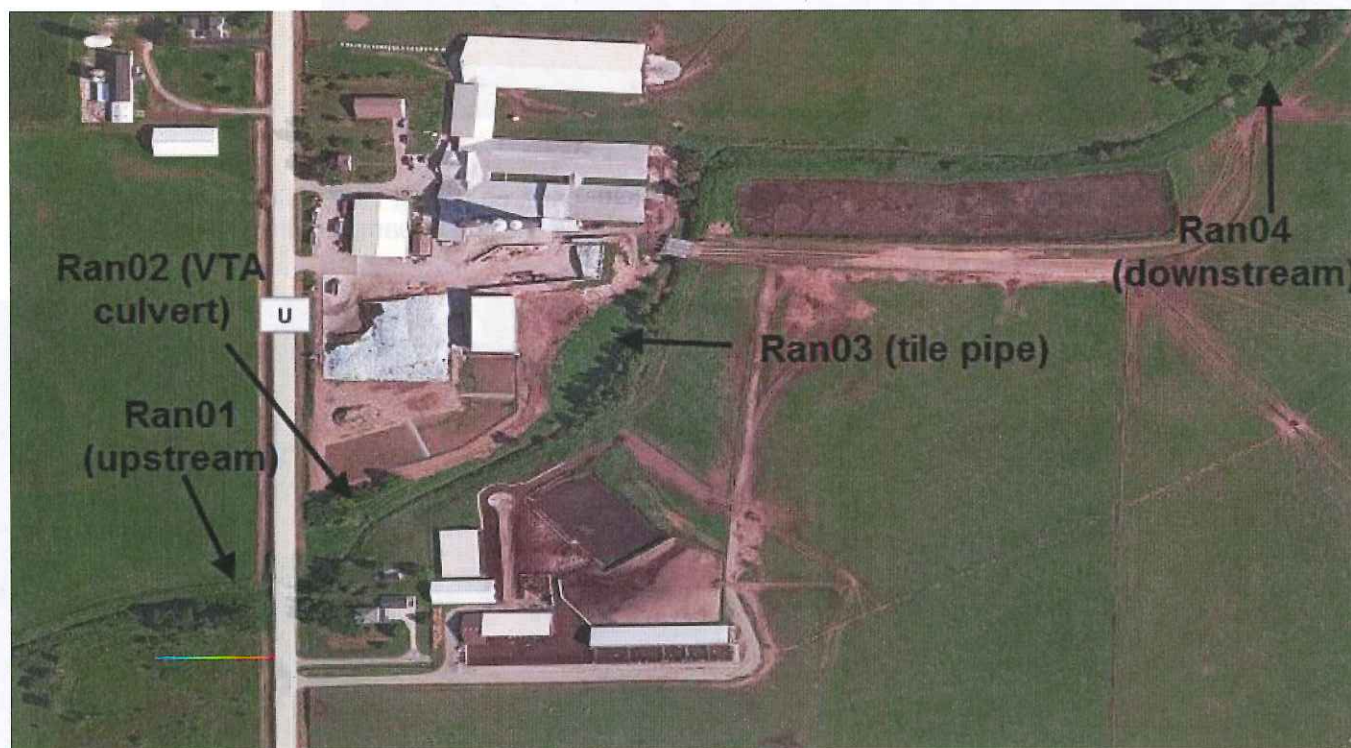
Photo 1: Overview of water sample locations

Ranovael Dairy's production area is split by Dutchman's Creek. On the west side is the freestall barns and feed storage area. The east side has the manure storages and heifer feedlot/housing area. Pasture lots are also located on the eastern side of the creek.

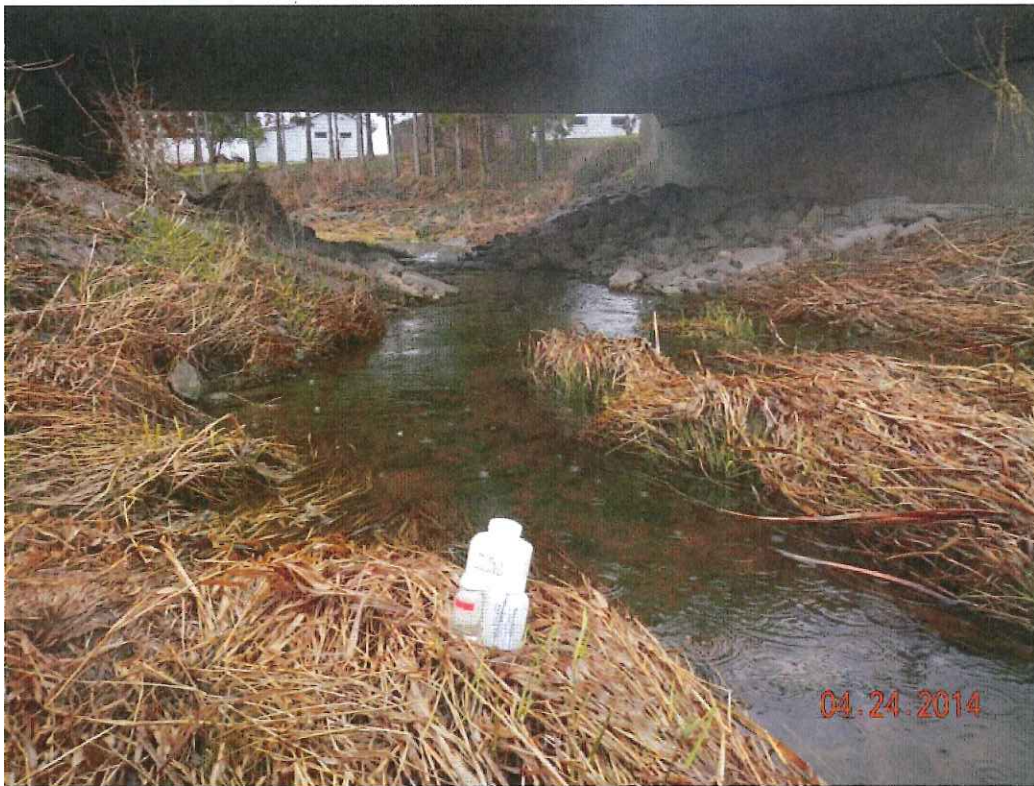
Sample “Ran01” was taken on the west side of the County Road U bridge crossing. Water clarity was good.

Photo 2: View at sample location looking east under bridge crossing—could see stream bottom.

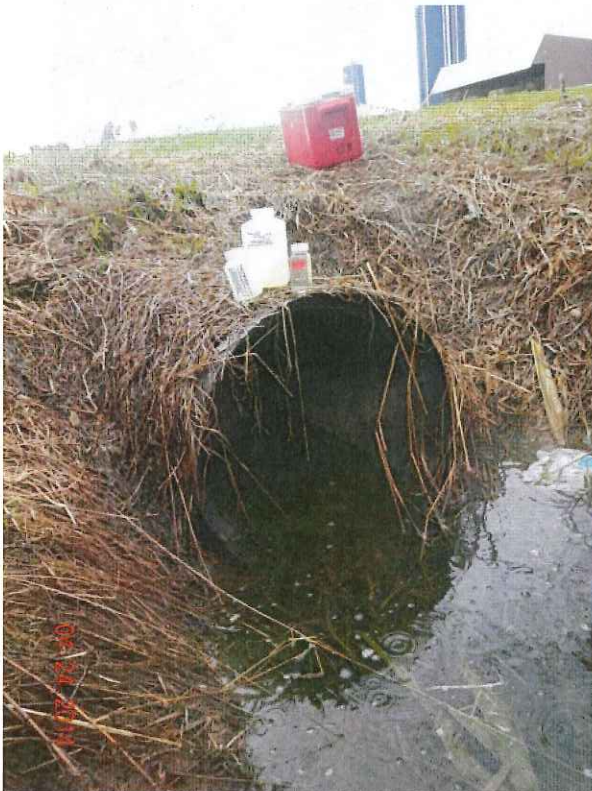
Sample “Ran02” was taken at the outlet of the vegetated treatment area (VTA). There is a culvert located at the end of the VTA that discharges directly into Dutchman’s Creek. At time of sampling the water looked fairly clear and there was no obvious odor.

Photo 3 (left): Close view of culvert outlet from VTA.  
Photo 4 (right): Looking south at flow path from culvert into Dutchman’s Creek.

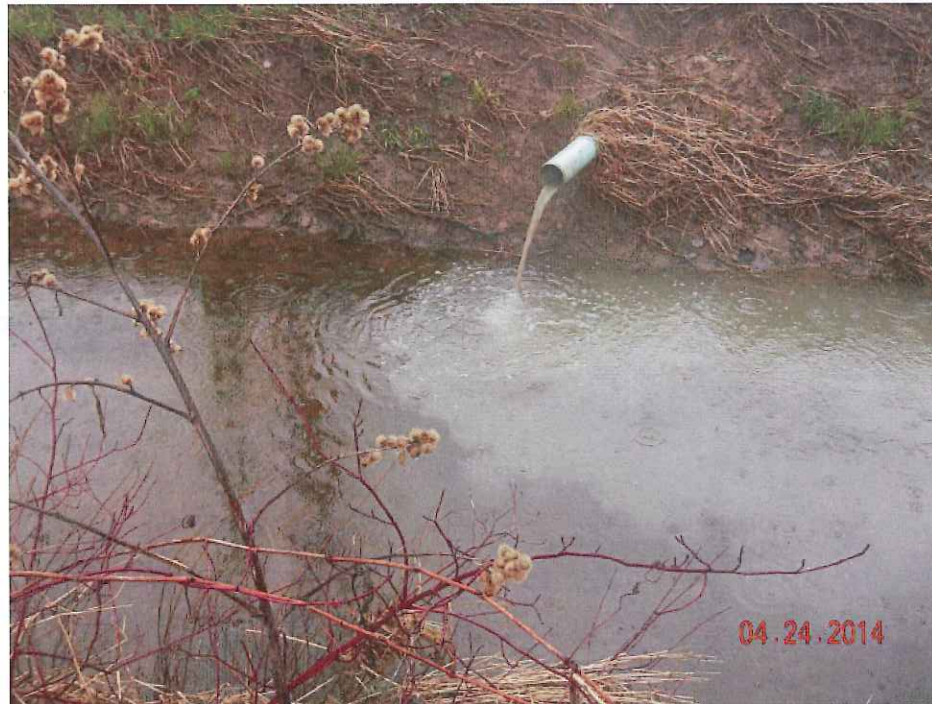
Sample "Ran03" was taken directly from tile pipe discharge that was discovered while inspecting areas along the stream. The discharge from the tile pipe was cloudy and odorous. Downstream of tile pipe discharge the stream water clarity was poor.

Photo 5: View looking west from eastern side of streambank at the PVC tile pipe discharge into Dutchman's Creek. Note the plume where discharge enters stream (upstream on right).

Water sample results confirm a discharge is occurring from the Ranovael Dairy production site. The permit prohibits discharges to navigable waters from the production area.

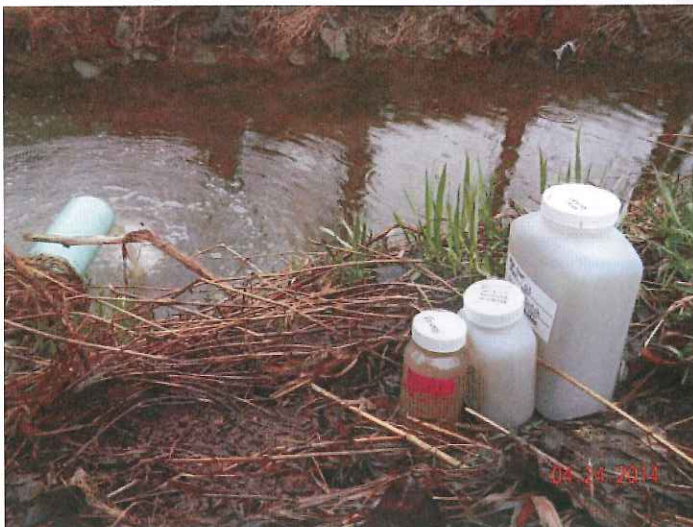
Photo 6: View from west side of streambank where tile pipe discharges. View of sample bottles with discolored discharge.

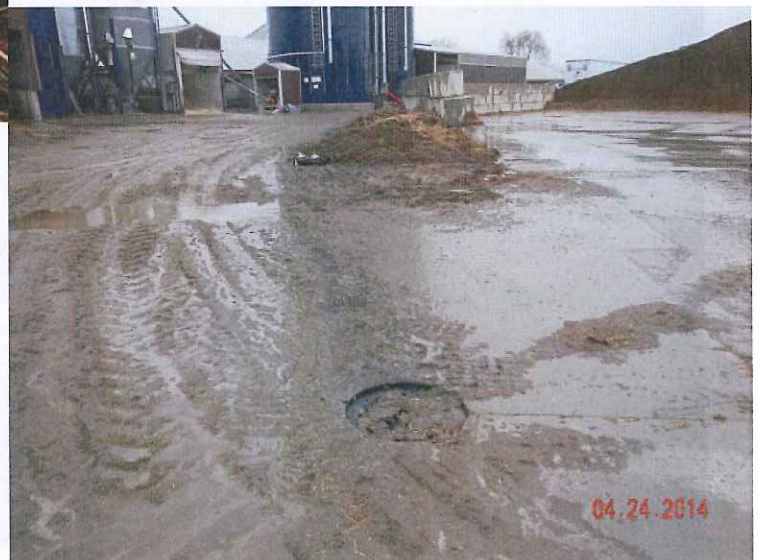
Photo 7: Source of tile pipe discharge is storm water manhole in photo foreground. Better diversions and housekeeping practices are required; plans will be necessary to address discharge.

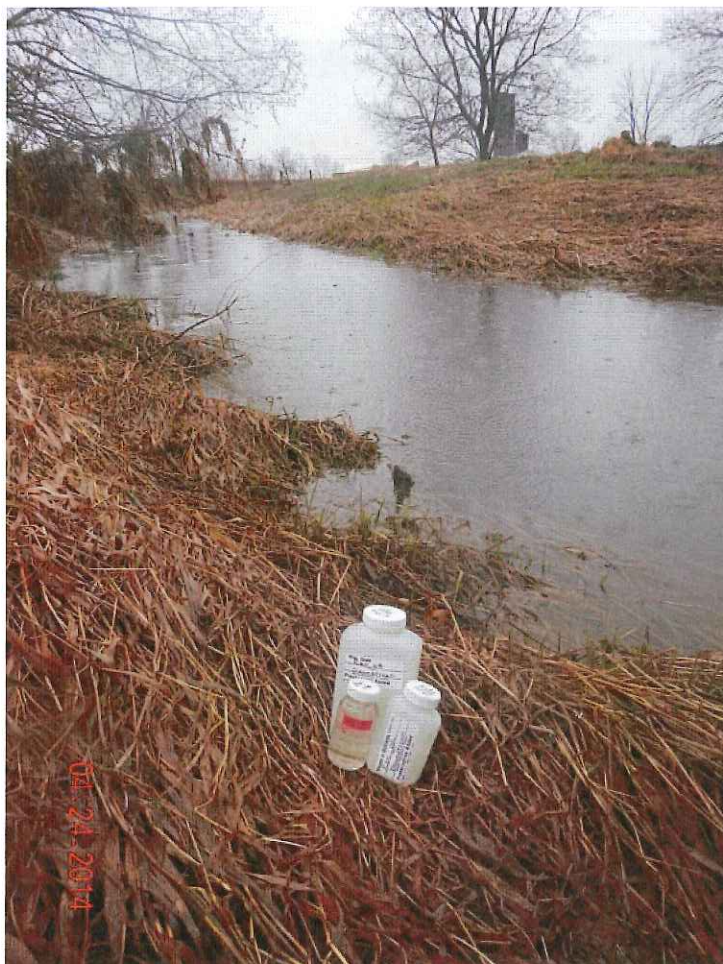
Sample “Ran04” was taken downstream just east of waste storage facility. Water clarity was noticeably less clear than the upstream sample location.

Photo 8: Looking west at downstream sample location.

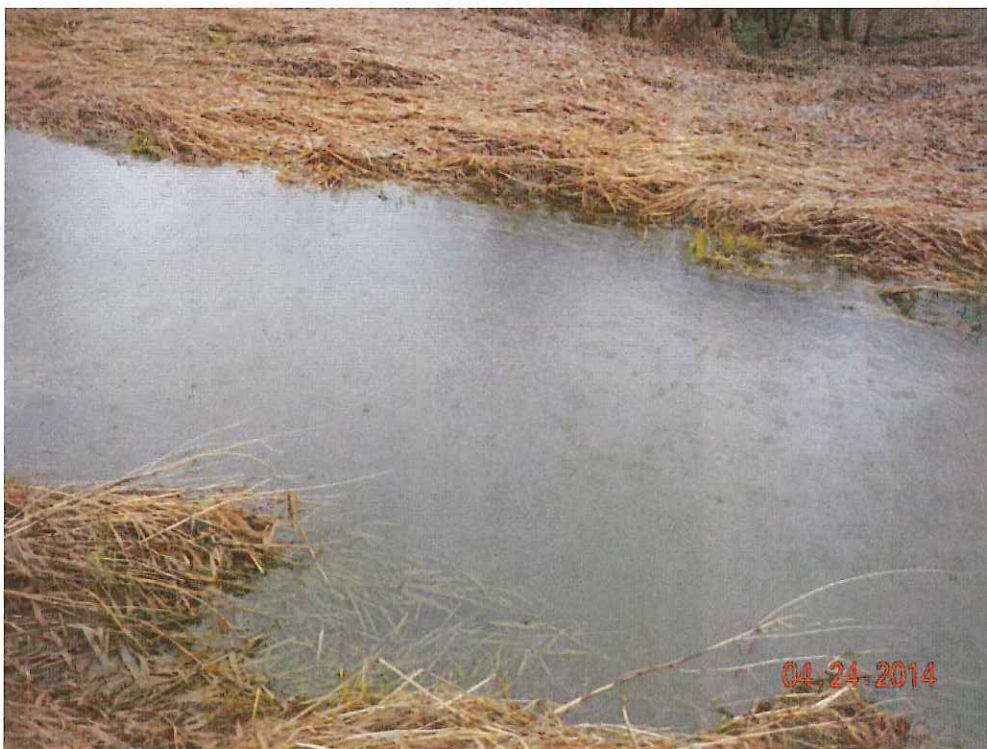
Photo 9 Close view of cloudy condition of stream water downstream of production site.

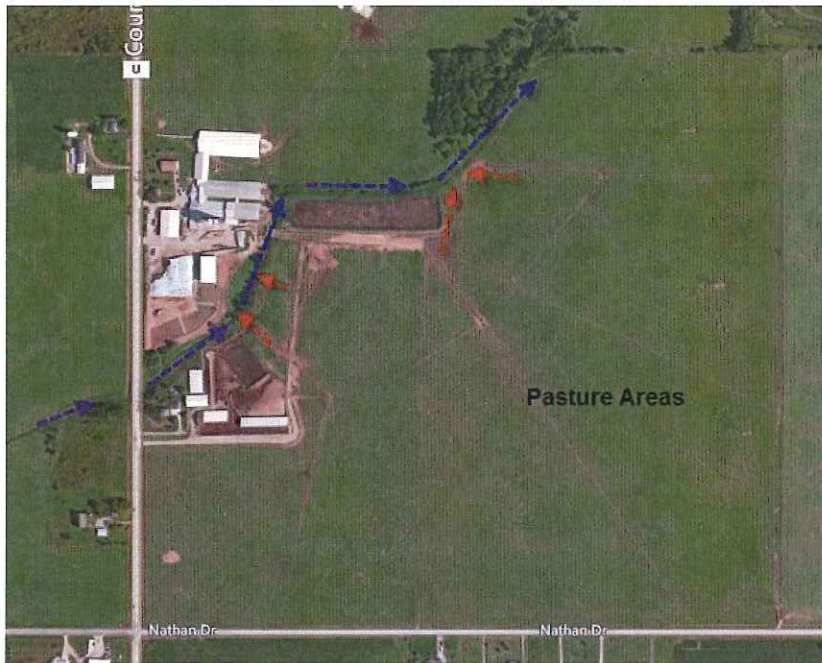
In general, the pasture lot areas appear to be well-managed. However, the lane and other heavy use areas used by cattle to get to the pasture may be causing discharges to stream (see brown arrows in Photo 9). All feedlot areas must have total containment of runoff into storage; there are some areas near heifer buildings that need to be addressed with clean water diversions and containment. Earth lots near stream must be permanently abandoned. Heavy use areas must be stabilized so runoff to stream does not occur.

Photo 10: Air photo overview of discharge areas from lots and pasture areas.

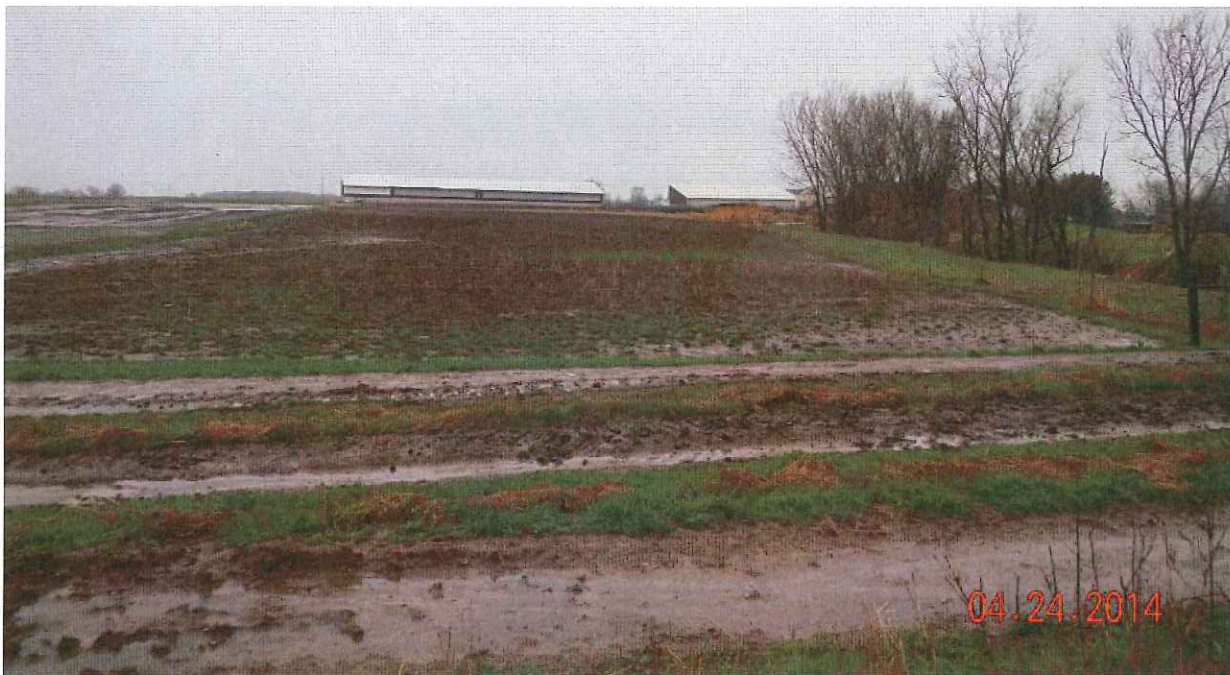
Photo 11: Looking south at lot area east of stream (tree-lined area). Fencing and lot should be completely abandoned due to proximity to stream.

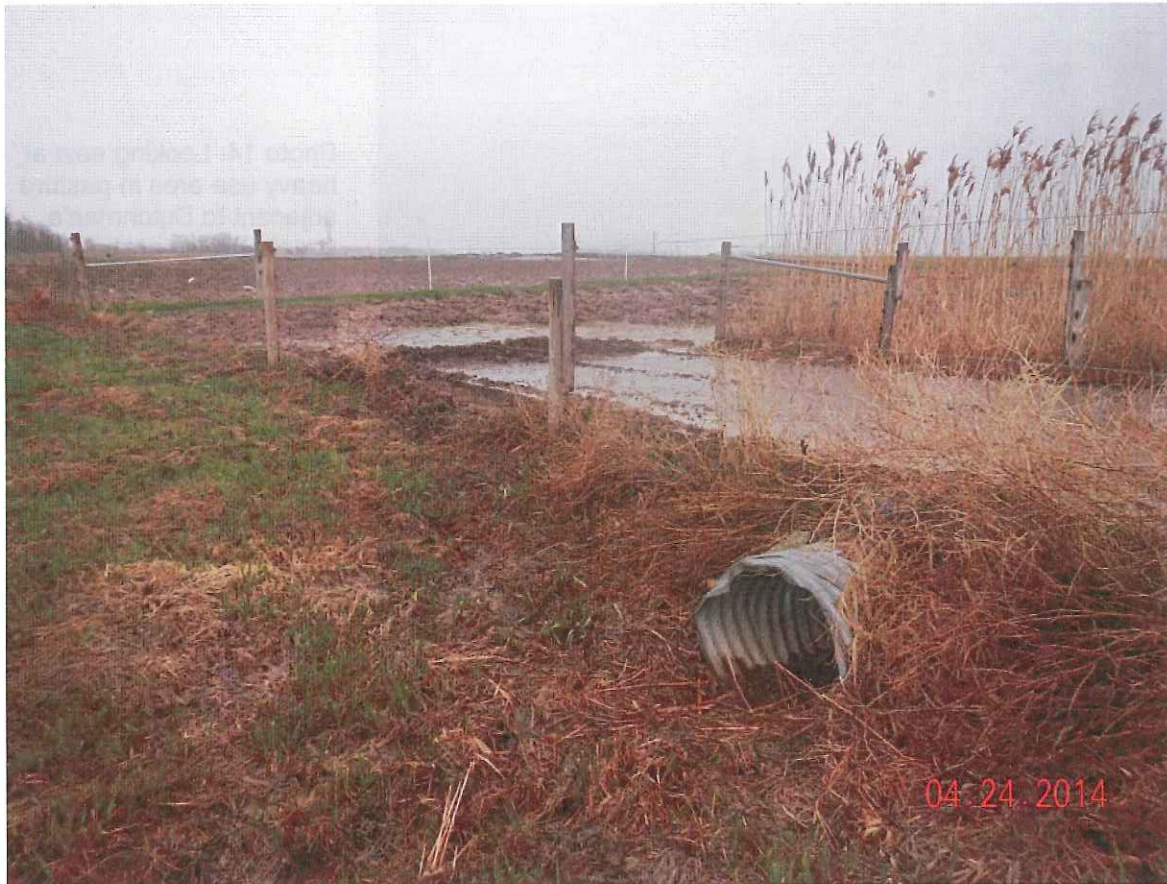
Photo 12: View of cattle lane area and culvert for upland drainage. During inspection, there was not enough flow to take a water sample in this location. However, due to site conditions it is likely feedlot runoff is discharging into adjacent stream.

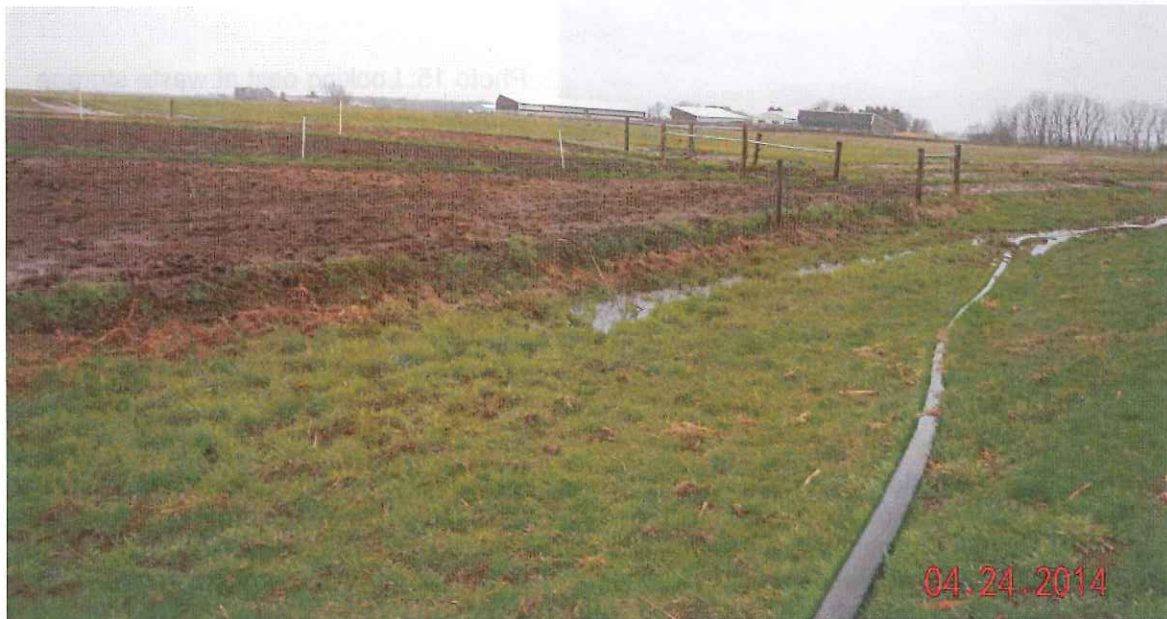
Photo 13: Looking south at heavy use area near cattle lane. Drainage ditch is directly adjacent that discharges into stream.

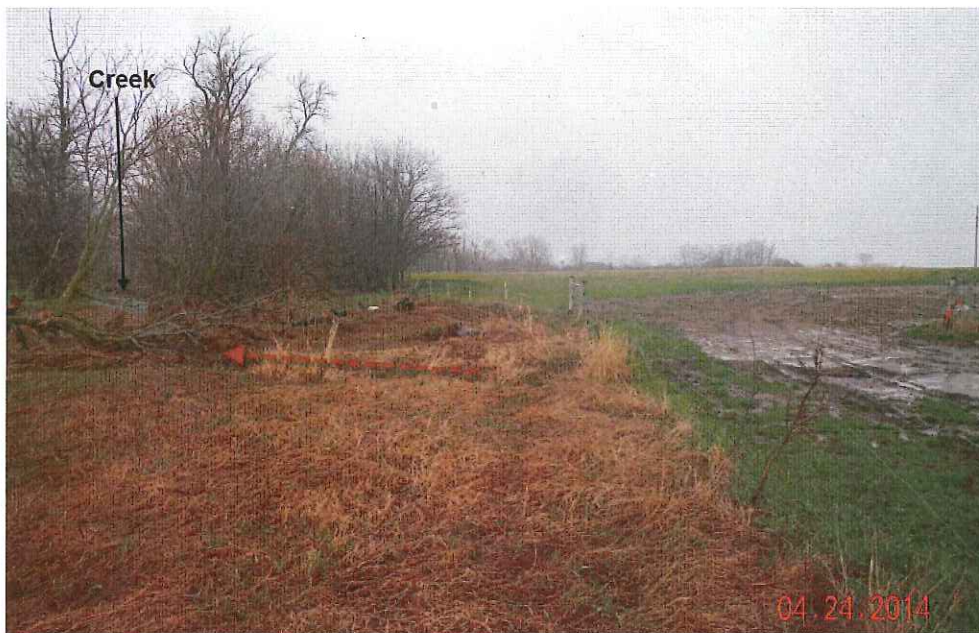
Photo 14: Looking east at heavy use area in pasture adjacent to Dutchman's Creek. Brown arrow shows location of channelized flow path to stream. At time of inspection not enough flow was present to take a water sample.

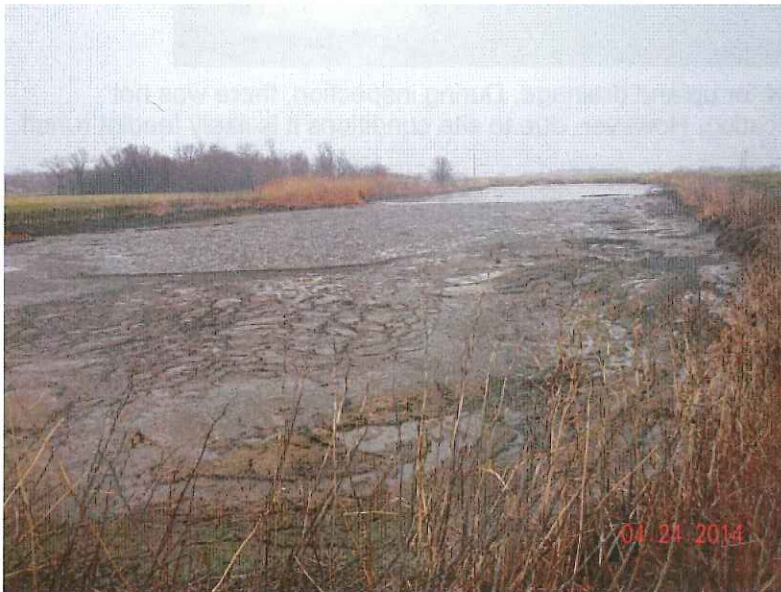
The large waste storage facility appeared to have safe manure operating levels at time of inspection. Markers had not been reinstalled and ruts and overgrown vegetation (reed canary grass) had not been addressed. Heifer waste storage facility was not inspected.

Photo 15: Looking east at waste storage facility.

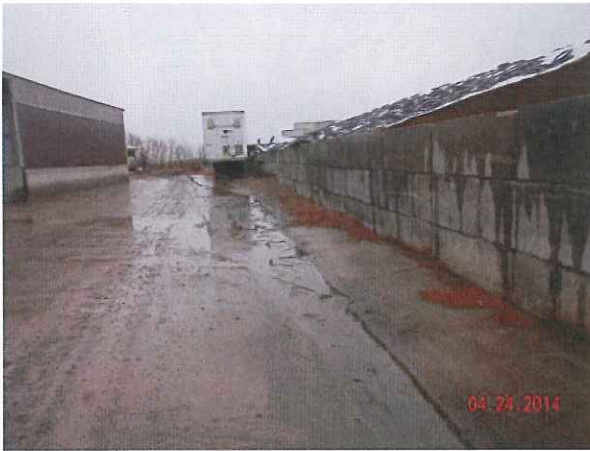
Photo 16 (left): Looking east along feed storage area. Walls are not sealed and leachate leaks out and commingles with storm water. Photo 17 (right): View looking south toward silage pile.

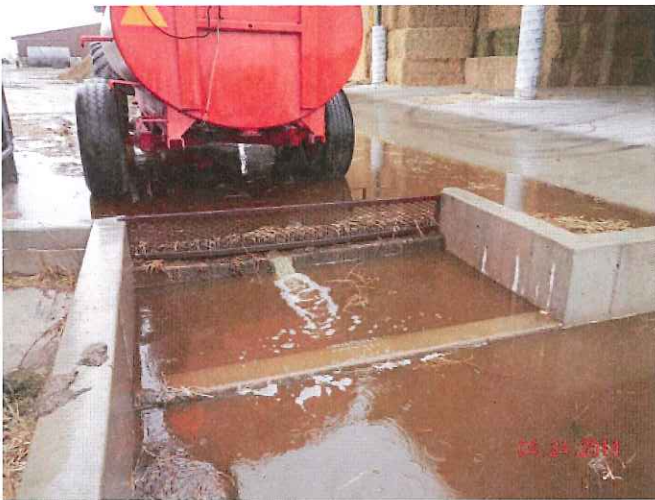
Photo 17 (left): Looking at runoff water bypassing full collection tank and flowing into VTA. Photo 18 (right): View of transfer line for feed storage runoff collection system under cattle bridge over stream.

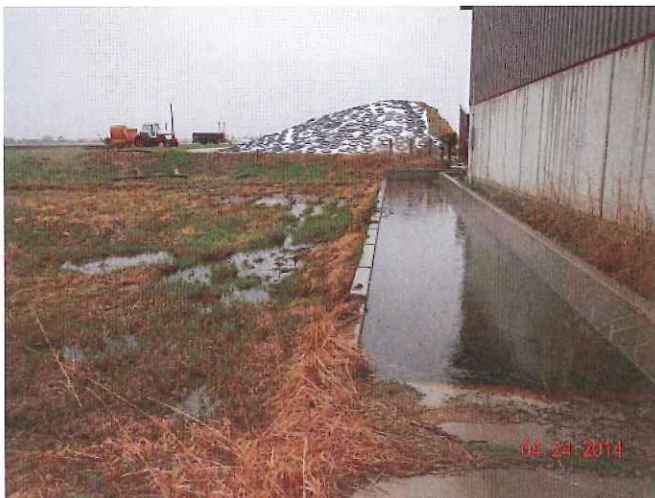
Photo 19 (left): Looking west at concrete spreader bar for feed storage runoff not collected into storage. Water was tinted brown. Photo 20 (right): Looking south at VTA that has some ponding and channelized flow paths that need attention.

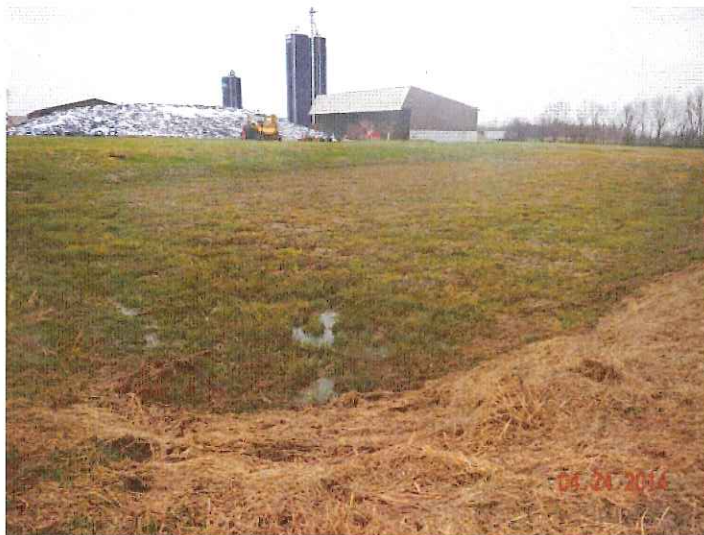
Photo 21 (left): View looking northeast at VTA.

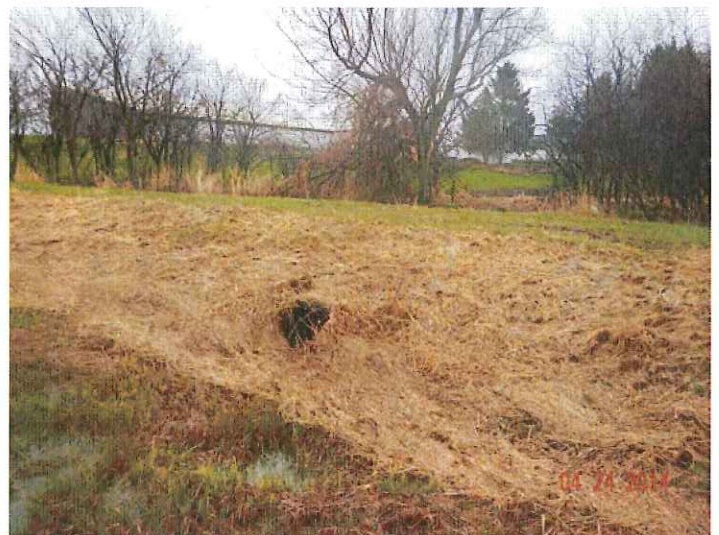
Photo 22 (right): View of culvert opening at end of VTA that discharges into stream.
